# The Search for *Tabique Pampango* in the Philippines<sup>1</sup>

Regalado Trota José\*

**Abstract:** Encountered in archival documents and historical accounts, the part of a building curiously known as *tabique pampango* is virtually unknown today. In general terms, *tabique pampango* refers to a thin wall of interwoven wooden or bamboo stakes and finished with a coating of lime plaster. *Tabique* is Spanish for any thin or partition wall. The descriptive *pampango* refers to the people of Pampanga, many of whom served in the colonial military. As we shall see, this type of construction was widely practiced throughout the Spanish colonial Philippines. The procedure for this type of wall, practiced by peoples around the world since ancient times, is the local version of what is referred to in architectural parlance as ‘wattle and daub.’ The earliest known reference to the technique dates from the early years of the 18th century. The earliest available mention of *tabique pampango* is from 1799. It was banned by the so-called Manila Earthquake Ordinances of 1880, though its construction continued elsewhere after that date.

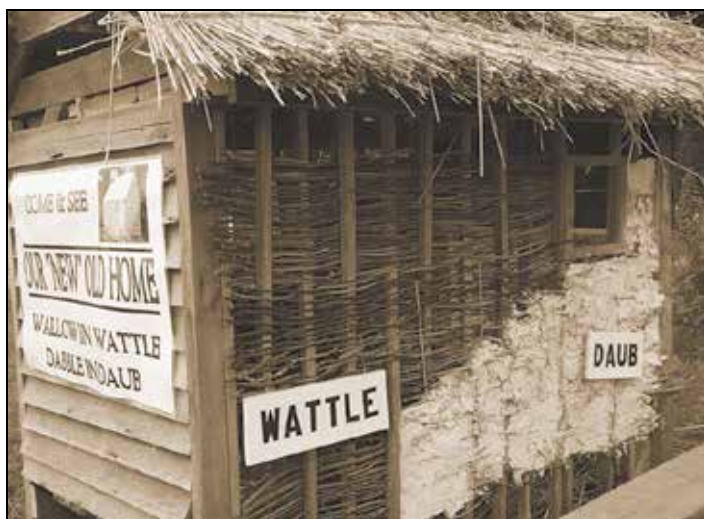
Fig. 1. Basic technique of wattle and daub.

The procedure for this type of wall, practiced by peoples around the world since ancient times, is the local version of what is referred to in architectural parlance as ‘wattle and daub.’ The wattle refers to a basketry-like matrix of wooden pieces; the daub is the layer of earthen material applied over the wattle (Fig. 1).

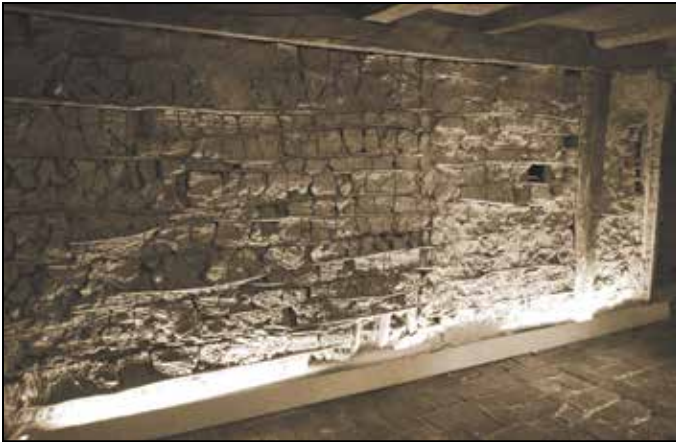
Fig. 2. An inner wall of pau-a-pique in the Monastery of the Immaculate Conception of Light, built in 1774. São Paulo, Brazil.

with a mixture of earth and vines, hair, etc. poured in as filling; both sides are then plastered. In Peru, Chile, and other parts of South America, the wattle and daub technique is known as *quincha*, derived from a Quechua word meaning enclosure.<sup>8</sup> In Brazil, the same procedure is known as *pau-a-pique*<sup>9</sup> (Fig. 2).

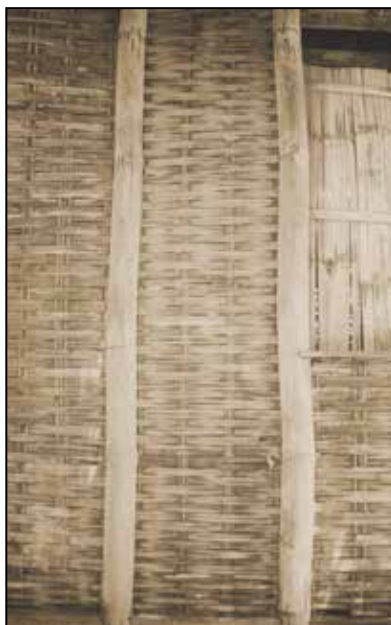
Fig. 3. A wattle of bamboo, seen in a house near the parish church, Oslob, Cebu.

The Philippines abounds in good examples of wattle construction in vernacular architecture (Fig. 3). Lime plaster for a sturdier wall was introduced in the Spanish colonial period. One of the first documentary sources for the wattle and daub technique in the Philippines is a report on the Ilocos, dating from 1709-1710.<sup>12</sup> The churches of Bangar, Candon, Bantay, and Cabugao consisted of low walls of stone topped by molave frames interwoven with bamboo and covered with lime. Most of these were begun 10 years earlier, in other words, in the late 1690s. This early, we see the difference of Philippine wattle and daub—what was later called *tabique pampango*—from the technique in Europe, America and Africa. Whereas mud was used in these lands, the rainy climate in the Philippines caused the replacement of earth with a mixture of sand, lime and water.<sup>13</sup>

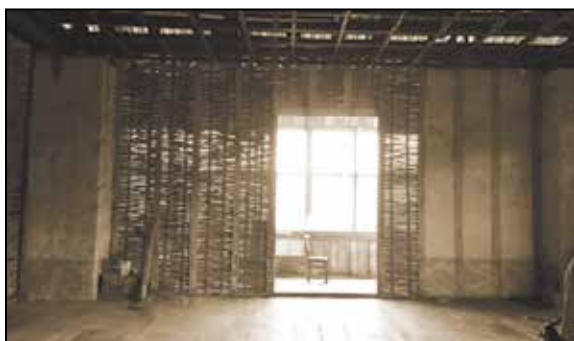
Fig. 4. View of wall, where the lime plaster has been stripped off sections of the wattle. The intact sections are painted white and indigo.

Figs. 4, 5, 6. *Tabique pampango* walls in convento, Alburquerque, Bohol. Photo: Regalado Trota José 2015

Comparison of photographs taken of *tabique pampango* enables a preliminary classification of the technique into two easily distinguishable types based on materials used. In the first type, bamboo slats (Visayan *salâsâ* or *sâsâ*, or Tagalog *patpat*) corresponding to the withies, are interwoven horizontally among the stakes or staves to form a basket-like screen. Examples can still be seen in the churches or conventos of places like Albuquerque (Figs. 4, 5, 6) and Baclayon (Figs. 7, 8), Bohol; Badian (Fig. 9) and Nueva Cáceres (Fig. 10), Cebu; Maria (Fig. 11) and Siquijor (Figs. 12, 13), Siquijor; Matalom, (Fig. 14), Leyte; Dapitan, (Fig. 15), Zamboanga del Norte; Jasaan (Figs. 16, 17), Misamis Oriental. In Zamboanga and Surigao, branches of the mangrove tree (*baras-baras* or *talibugsak*) were interwoven in the same way as bamboo.

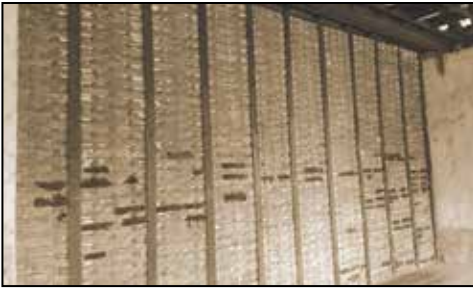
Fig. 5. Back view of unplastered wall.

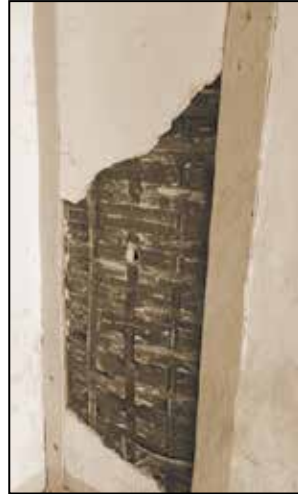
Fig. 6. Detail of plaster peeling over wattle.

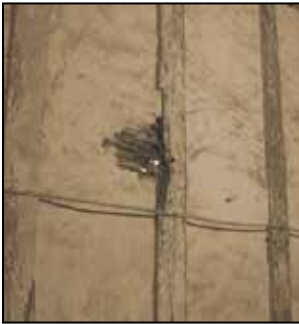
Fig. 7. *Tabique pampango* partition wall in convento, Baclayon, Bohol.

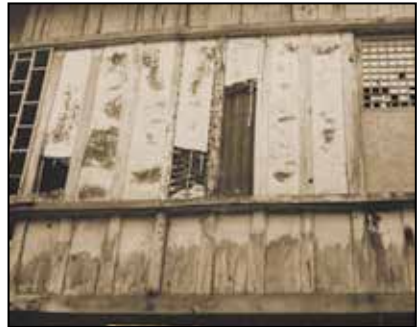
Fig. 9. View of a wall in the convento of Badian, Cebu. The bamboo wattle can be discerned under the daub.

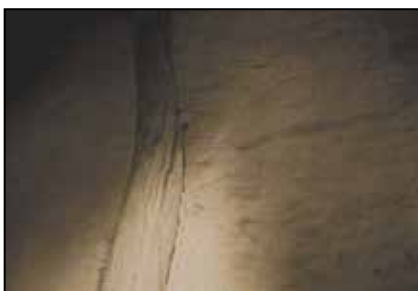
Fig. 10. Close view of the *tabique pampango* linking the church with the convento, Nueva Caceres, Cebu.

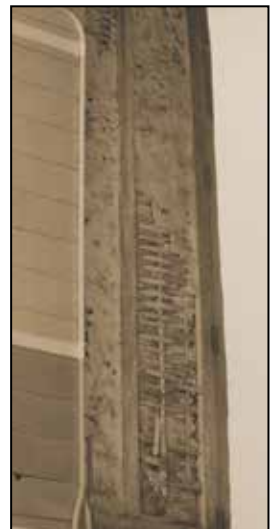
Fig. 11. Exterior wall of unidentified building in the church compound of Maria, Siquijor.

Locality	Church	Convento	Others
Canoan	walls	--	--
San Juan	walls	walls	--
Maria	walls	-- ( <i>Fig. 11</i> )	--
Siquijor	--( <i>Figs. 12, 13, possibly after 1886</i> )

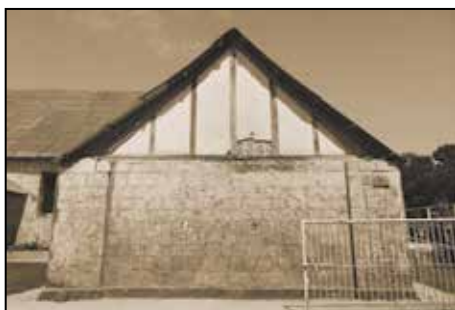
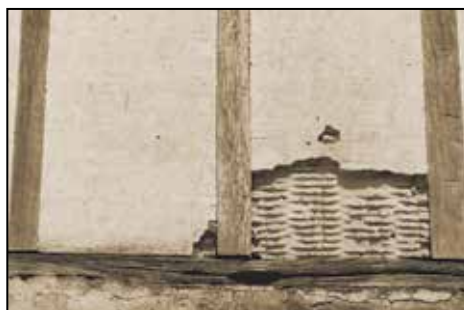
Figs. 12, 13. *Tabique pampango* wall above baptismal font of church and detail, Siquijor, Siquijor.

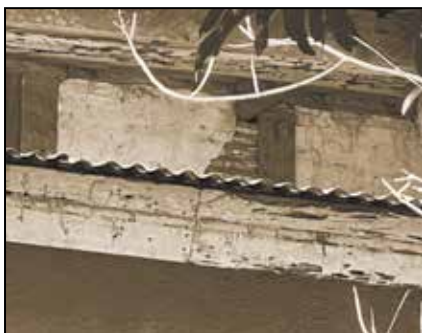
Fig. 14. *Tabique pampango* on upper section of the convento, Matalom, Leyte.

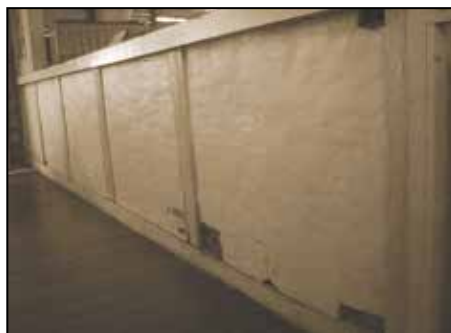
Fig. 15. Portion of half-wall of *tabique pampango* in the convento of Dapitan, Zamboanga del Norte.

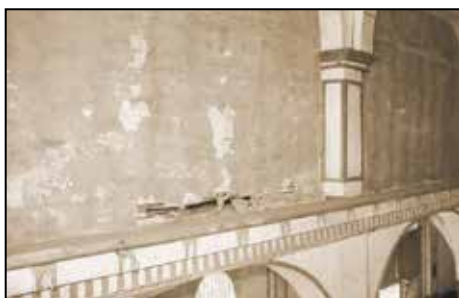
Figs. 16, 17. *Tabique pampango* in the upper section of the nave of the church, Jasaan, Misamis Oriental.

Fig. 16. Wall facing the nave, with indigo and white paint.

*pampango* walling in various parts of the buildings. Ironically in Jasaan, the *tabique pampango* in the upper reaches of the nave, corresponding to its clerestory (Figs. 16, 17), was taken down a few decades ago and only a few elder citizens remember that it was ever there (they recount the plaster dust falling on their heads). However, in the past couple of years a strong parroquial movement is bringing back the wattle on the upper walls, and the lime will be daubed when everything is in place (Figs. 33, 34). The community decided to revive the *tabique pampango* upon completion of a Conservation Management Plan prepared by the University of Santo Tomás Graduate School Center for Conservation of Cultural Property and Environment in the Tropics (CCCPET), in coordination with the parish of the Immaculate Conception and the Archdiocese of Cagayan de Oro.

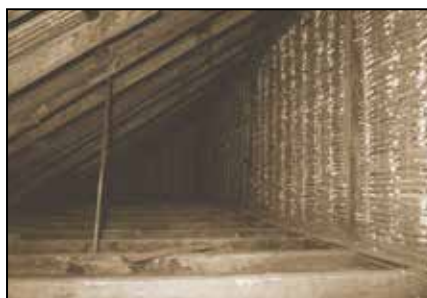
Fig. 17. Rear of unplastered wall. Photo: Luis Faustino, 1982

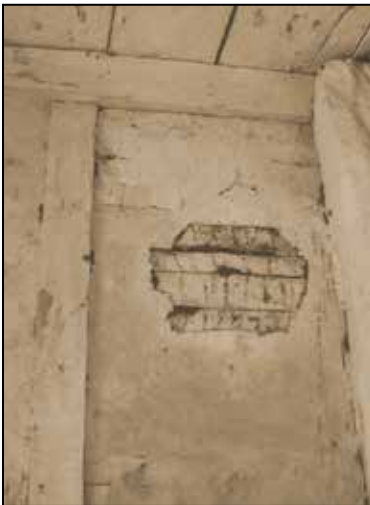
Fig. 18. Detail of tabique pampango wall in ground floor of convento, Dauis, Bohol.

In the second type, instead of bamboo slats, short lengths of lumber are used. These are laid horizontally, and lightly hacked with an axe or hatchet to provide a rough surface for the lime plaster to adhere to. Examples can still be seen in Dauis (Figs. 18, 19), Bohol; and Argao (Fig. 20), Boljoon (Fig. 21), and Dalaguete (Fig. 22), in Cebu. One has to consult early photographs to see how a complete wall of this kind would look like, as in Oslob, Cebu, before it burned down (Fig. 23). This second type has more versions, perhaps developed according to the availability of materials and skills. A similar technique was used for churches in Mindanao like Jabonga (Figs. 24, 25), Agusan del Norte; and Balingasag, Misamis Oriental, except that all the pieces had been painstakingly wound around with durable *cabo negro* rope.

Locality	Church	Convento	Others
Tagbilaran	---	combined with stone	--
Dauis	walls of the old church	-- ( <i>Figs. 18, 19</i> )	--
Panglao	temporary church	temporary convento	--
Baclayon	--	with cut coral stone and lime mortar masonry ( <i>Figs. 7, 8</i> )	--
Corella	with cut coral stone	with cut coral stone	
Alburquerque	temporary church	upper part, combined with planks ( <i>Figs. 4, 5, 6</i> )	--
Balilijan	with hardwood posts	with hardwood posts	--
Catigbian	new church, on 1 ½ <i>vara</i> <sup>27</sup> of stone base	walls	--
Paminguitan	walls	walls	--
Antequera	temporary church	temporary convento	--
Calape	on a stone base 1 <i>vara</i> high	lower part, on a stone base	--
Inabanga	walls beyond the façade and middle of the building, which were of masonry	walls	--
Getafe	on masonry base of 2 <i>varas</i> , combined with double paneling	--	--
Talibong	--	combined with planks	chapel in barrio Tabigue

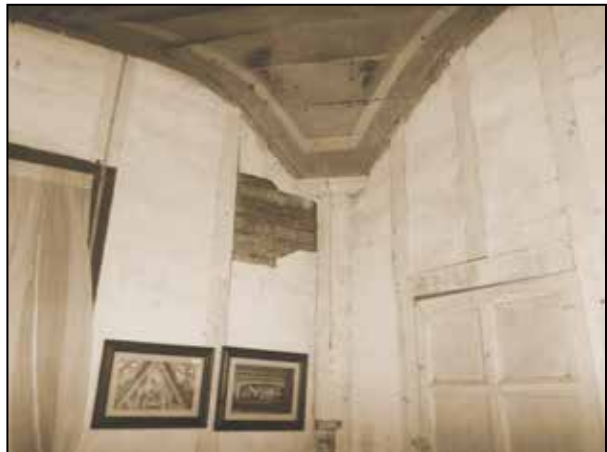
Fig. 19. Detail of tabique pampango wall in main hall in upper level of convento, Dauis, Bohol.

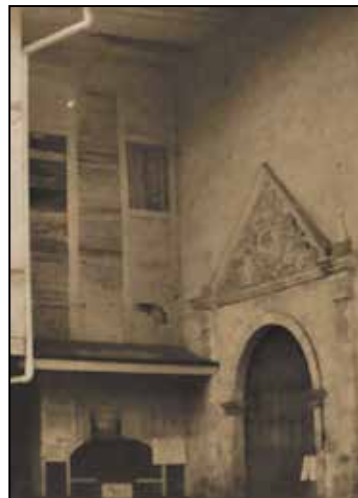
Fig. 20. Board-type of tabique pampango in junction between convento and church, Argao, Cebu.

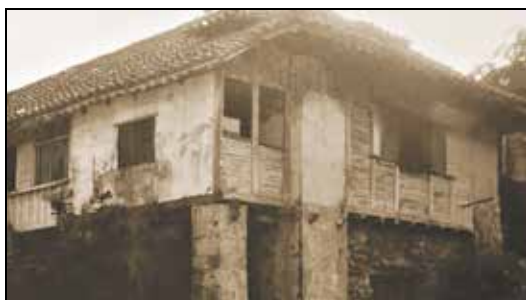
Fig. 21. Board-type of *tabique pampango* at one of the convento, Boljoon, Cebu. Sections of the plaster are still extant.

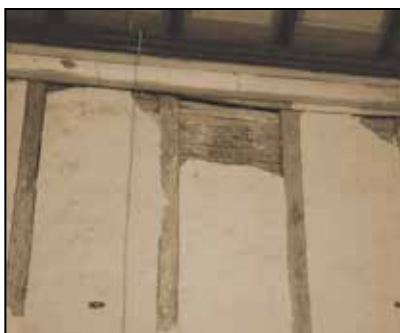
Fig. 22. Board-type of *tabique pampango* in convento, Dalaguete, Cebu.

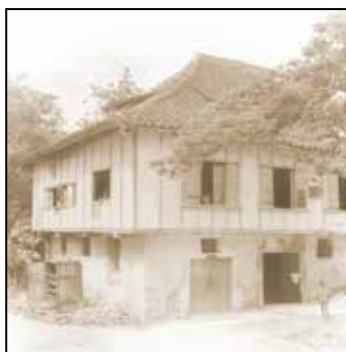
Fig. 23. Convento of Oslob, Cebu. Most of the plaster is still intact, concealing the board-type of *tabique pampango*.

Locality	Church	Convento	Others
Cebu Cathedral	--	upper level and partitions	--
Cebu Southern Vicariate			
Talamban	on a stone base	--	--
Cordoba	upper half of the walls on a <i>cota</i> base	upper part	--
El Pardo	upper half of the walls on a stone base	mezzanine, with wooden planks	--
Naga	--	inner divisions	--
Sibonga	walls combined with hardwood posts new church being constructed	--	--
Nueva Caceres	upper third of walls on stone base	-- [Fig. 10; possibly this part was built after 1886]	upper part of belltower, on stone base
Oslob	--	upper level (Fig. 23)	Chapel in Santander; on a <i>cota</i> base

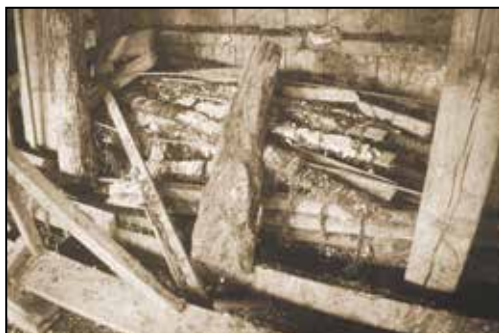
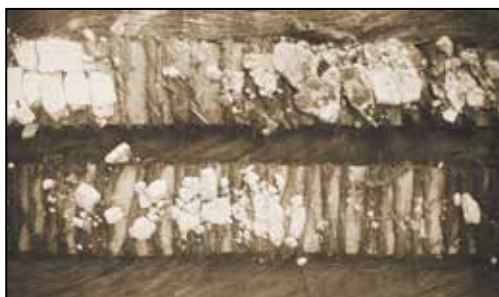
Figs. 24, 25. Remains of wood boards from discarded *tabique pampango* wall in the apse of the church of Jabonga, Agusan del Norte, with remnants of cabo negro and lime plaster.

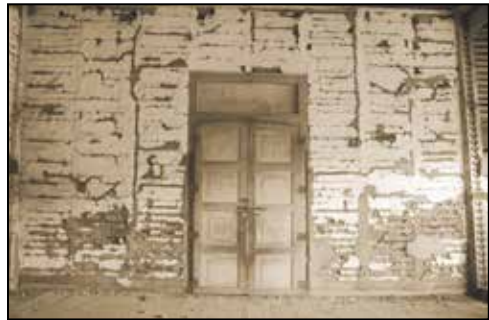
Fig. 27. One of the main doors flanked by *tabique pampango* walls.

Figs. 26 to 29. *Tabique pampango* in the abandoned convento of Urdaneta, Pangasinan Photo: Sabino Mejia, 2013

A pleasant surprise in 2013 was the discovery of a variation of the second type, some 700 kilometers north of the *tabique pampango* “heartland” in the Visayas. In the convento of the cathedral of Urdaneta, Pangasinan, partition walls were made of slim boards of wood laid one above the other, with some space in between to accommodate a rough lime mixture with stones. The boards were inserted like louvers into slanted grooves chiseled out of the vertical frame posts. Both sides of the walls were fitted with these “louver” frameworks. Lengths of thin rope were tied all over the wooden pieces, forming parallel rows or x’s, to enable the adhesion of the lime plaster (Figs. 26, 27, 28, 29). As noted above, this convento, which is now abandoned, was built in the late 1870s or early 1880s. It is a unique, if labor-intensive, evolution of *tabique pampango*, and nothing else is known about how it was developed or where it came from.

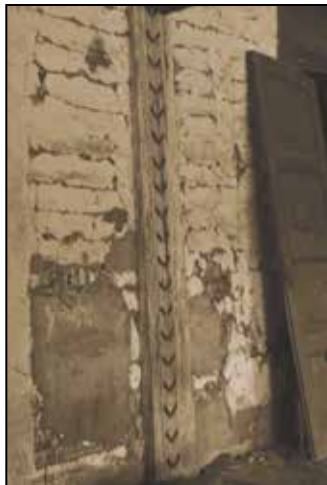
Fig. 28. Closer view of the upright frame post with diagonal slots for the horizontal boards.

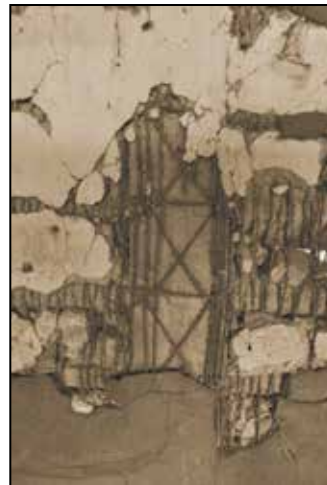
Fig. 29. Close-up of the boards wound with rope, and with clumps of lime plaster.

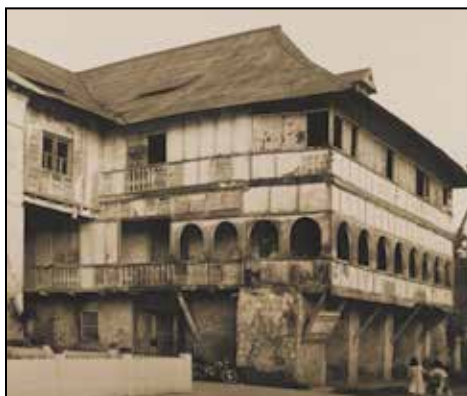
Fig. 30. General view of the convento. The bamboo *tabique pampango* is used for the arcaded gallery fronting the road. The board-type *tabique pampango* is used for the sides of the same gallery and the junction with the rear of the church.

Figs. 30, 31, 32. Two types of *tabique pampango* in convento of Loboc, Bohol (before the 2013 earthquake).

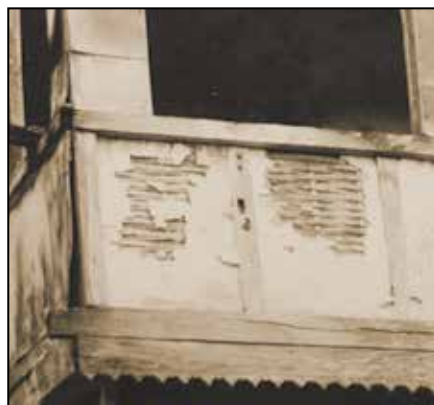
Fig. 31. Bamboo wattle showing through the plaster of the arcaded gallery.

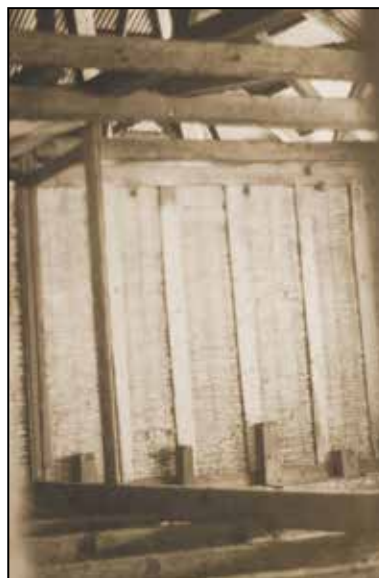
Fig. 32. Unplastered rear of bamboo *tabique pampango* in the third level of the convento.

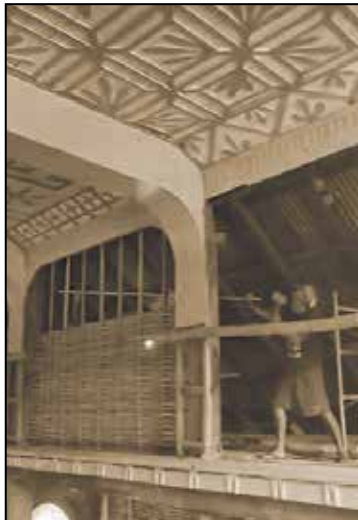
Fig. 33. Re-installation of *tabique pampango* in Jasaan.

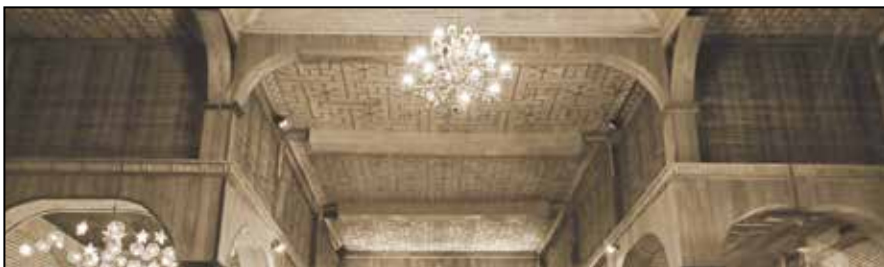
Fig. 34. Most of the wattle was installed by Christmas, 2023.
